NAVAL POSTGRADUATE SCHOOL

MICROSTRUCTURAL COMPARISON OF
POSITIVE FLOAT AND TRICKLE DISCHARGE
OPERATIONS ON THE POSITIVE ELECTRODES
OF SUBMARINE STORAGE BATTERIES
WITH LEAD-CALCIUM ALLOY GRIDS

September 1976

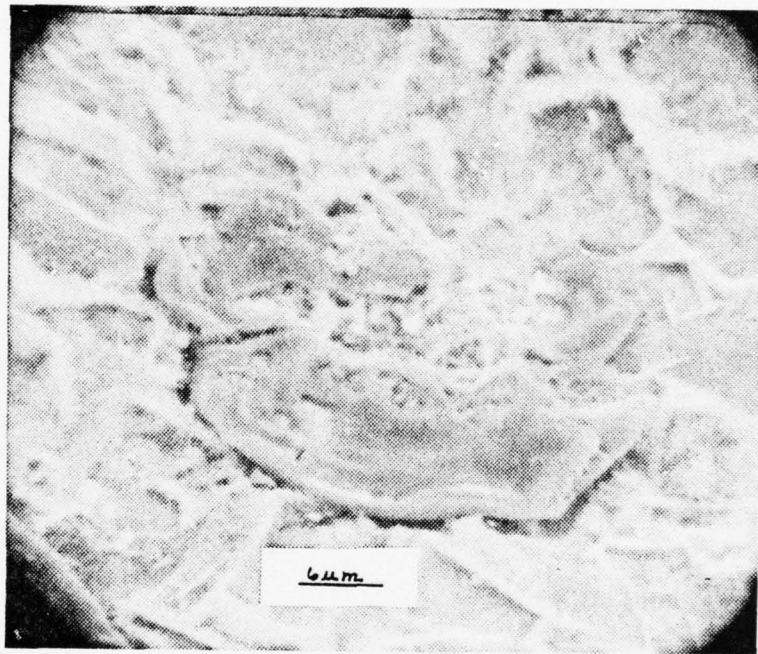
Figure 47 - Exterior of grid showing a partially transformed lead sulfate crystal. The dendritic structure is seen around the periphery of the PbSO_4 ; 4 cycle PbCa positive plate, trickle discharge routine, plate is in charged condition, 2100x.

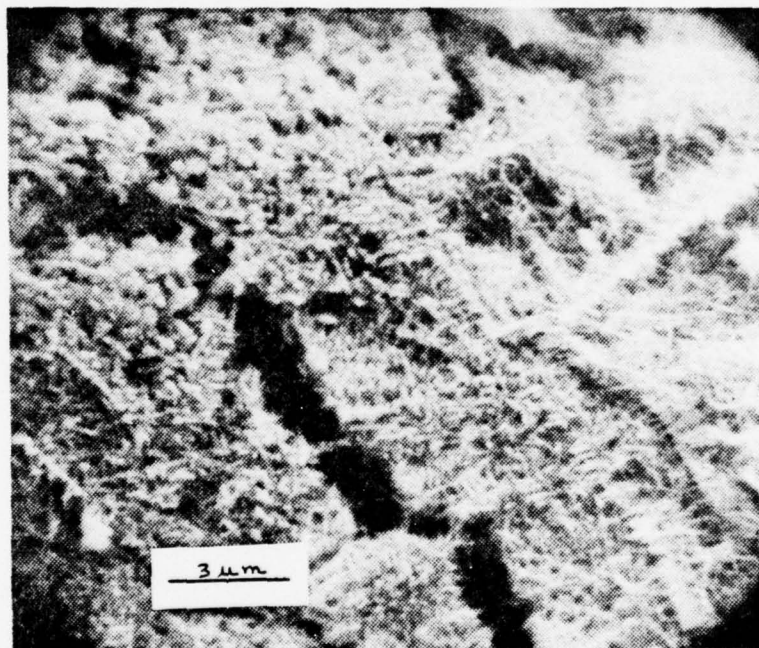
Figure 52 - Exterior of grid with active material broken away showing break in dense layer covering grid surface; spiny crystals and dendritic shells are visible. 13 cycle PbCa positive plate, trickle discharge routine, plate is fully charged, 5900x.
